Optimization of Perturbation Effects and Radiotherapy Facilities of the General Hospital of Douala; Staff, Equipment and Infrastructure

Abstract

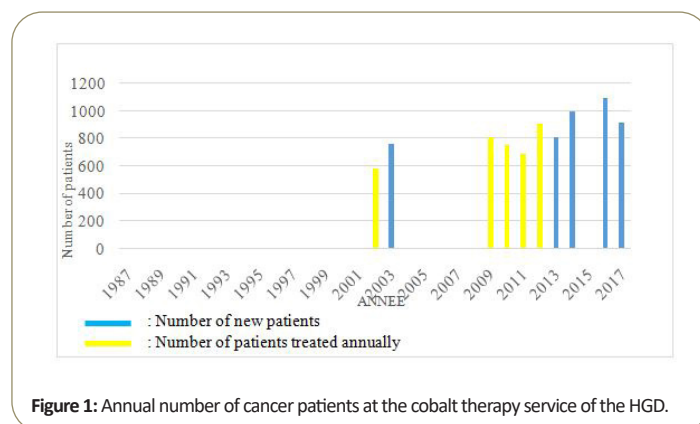
Specification of the radiotherapy service studied: Figure 1 represents newly diagnosed patients (blue band) and annual diagnosed patients (yellow band) at the GHD. The unit is made up of 16 members of whom; 4 did not contribute to our study because of their absence in the service throughout our stay at the GHD and finally 1 who did not respond favorably to our inclusion criteria. The therapy had no regular archives from its creation till 2001 and has an average number of 500 cancer cases annually.

Figure 1: Annual number of cancer patients at the cobalt therapy service of the HGD.

The curve in green indicates standard number of personnel for a centre having an annual number of 1000 patients as prescribed by the IAEA. Since the GHD receives an annual number of about 400 patients, we therefore derived another standard for a centre treating less than 500 patients per year which is indicated in red. The blue curve indicates the situation in GHD.

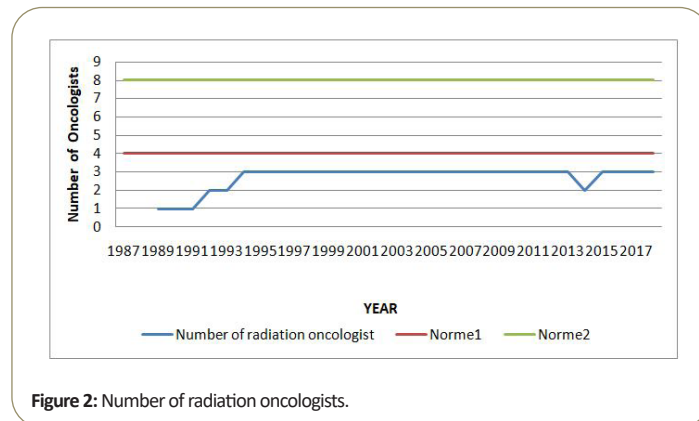
Radiation Oncologist (RO): From **Figure 2**, we see that the center began its activities in 1989 with a compliance rate of 25% relative to the specialty radiation oncologist (RO) until 1991. In 1992, this rate increases to 50% and then to 75% in 1994, then relapse in 2014 to 50% with the death of one of the radiotherapists who was replaced the following year (2015) by another; restoring the compliance rate to 75%, which will remain until 2018. Since the creation of this service at the HGD, the maximum number of radiation therapists is 3, well below the minimum of 4 recommended radiation therapists by the IAEA (2007). Following the death that occurred in the specialty in 2014, between 2013 and 2015 the work of the two ROs present had considerably increased because the number of patients by radiotherapy oncologist increased from 270 patients per RO in 2013 to 333 patients per RO in 2015; figures already well above the IAEA standard (2007) in 2013 and being 200 to 250 patients annually per RO. This overload situation has disrupted treatment by increasing not only the waiting time in consultation with patients but also the waiting time before care. It turns out

Figure 2: Number of radiation oncologists.

that to compensate for disruptions in this specialty, additional recruitments must be made: it will for example recruit 1 RO to be in compliance with the standard 1 or 5 additional RO to be in compliance with the standard 2.

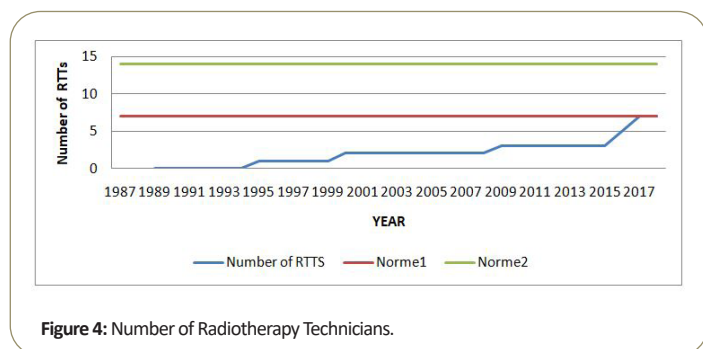
Radiation Therapy Technicians (RTTs): According to **Figure 4**, the RT service at the GHD operated without a RTT from 1989 to 1994. In 1995, the rate increases to 14.28%, then to 28.57% in the year 2000, then 42.85% in 2009 before reaching the norm 1 in 2017. These multiple variations in the compliance rate for the specialty of RTTs allows to realize that before 2017, the handling of the treatment devices within the service was assured by the specialists of RT (RO and PM) between 1989 and 1994, something having a significant impact not only on the radioprotection of the

Figure 4: Number of Radiotherapy Technicians.

personnel involved but also on the circuit of patient treatment by increasing the waiting time of the latter. Thus to solve these perturbation due to the insufficient number of RTTs although having considerably evolved until 2017, the GHD should equip itself with 7 additional RTTs in order to meet the norm 2 to be able to serve properly and efficiently the number of growing patients she has been responsible for in recent years.

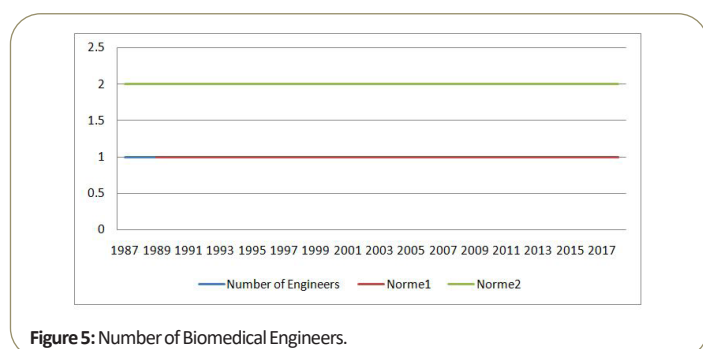
Biomedical Engineers (BE): In view of Figure 5, from 1989 to 2018, the HGD operates with 100% compliance with norm1 for the biomedical technician specialty. Several devices during their existence at the GHD were abandoned due to technical failures that he could not ensure the restoration or maintenance. Moreover these disturbances due to the incompetence of the biomedical technician in the RT service entails long interruptions in the treatments because of the uncorrected breakdowns. To compensate for this the HGD should contribute to the training of a biomedical technician specialized in RT service devices as recommended by the IAEA standards, for a better understanding of the technology as well as to ensure smooth logistics to obtain spare parts in case of failure where the need arises.

Figure 5: Number of Biomedical Engineers.

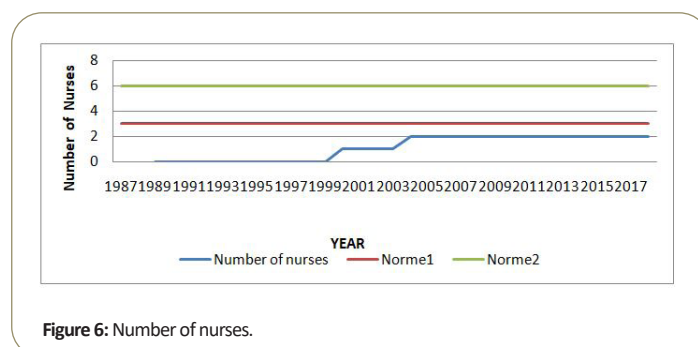
Radiotherapy Nurses (RN): From the opening of the service until 1999, the latter did not have any nurses (Figure 6). It was in the year 2000 that the compliance rate for this specialty became non-zero, rising to 33.33% then to 66.66% in 2004 and remained the same and lower than the norm 1 (3 RN) up to 2018. This last value is equivalent to the maximum rate obtained at the GHY in the same specialty [3]. This reduced number of nurses sometimes leads to frustrations in the service because with the large number of patients received daily, several tensions arises because of the feeling of rejection developed by some patients feeling misunderstood or misguided. Thus, these disruptions related to the insufficient number of nurses could be ended if

Figure 6: Number of nurses.

the need for 4 additional nurses for the service is filled in order to reach the norm 2. Allowing the listening and a more efficient follow-up of each patient.

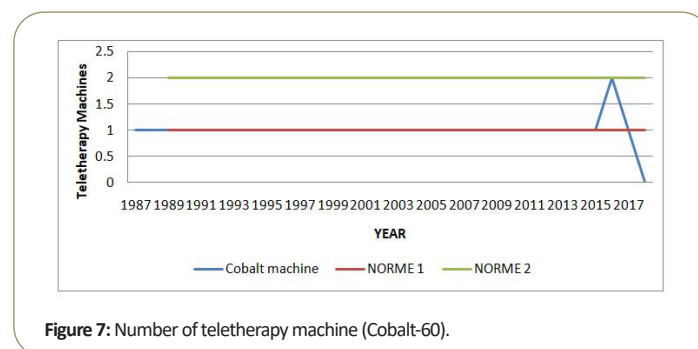
Megavoltage teletherapy unit: From 1989 to 2015 (Figure 7), the GHD RT service operates at 100% compliance with norm 1 in megavoltage teletherapy with a cobalt bomb (ALCYON II) for a number of patients approaching 1000 in 2014. In 2016, with the start-up of a second cobalt teletherapy machine (EQUINOX 100); this rate got to norm 2 before falling back to normative score 1 following an uncorrected ALCYON II failure in 2017, then becomes zero in 2018 following the technical failure of EQUINOX 100. Thus between the opening of the center and 2015 although evolving under norm 1 in megavoltage teletherapy unit, the GHD has been confronted with a growing number of patients and difficulties due to the lack of maintenance of teletherapy devices.

Figure 7: Number of teletherapy machine (Cobalt-60).

This is more alarming from 2012 with the technical breakdown that affected the GHY's RT service. The GHD receives a large flow of patients. The GHD ALCYON II alone served a population of more than 20 million (if we ignore the number of patients from neighboring countries in Cameroon), which is well beyond the acceptable global standard of: 1 megavoltage machine for 120000-250000 people proposed by [7]. Thus, if we refer to this additional standard, the national level shows the perturbation due to the insufficient number of RT machines per inhabitant, which in turn leads to the displacement of patients from remote regions, the financial cost in the quest for therapy, accommodation problems and languages etc. curbing the best care of patients.

Moreover, despite the fact that 2016 represents the only year in which the center reached normative score 2. As early as 2017, a series of technical breakdowns (that of Halcyon II and then EQUINOX 100) completely paralyzed the RT service in 2018. Failure coupled with the growing number of patients constitutes a significant disruption in the service. Indeed, these disturbances inevitably cause patients to increase the waiting time before the therapies, and an extraordinary use of RT devices in order to respect the treatment protocols established for each patient before the breakdowns.

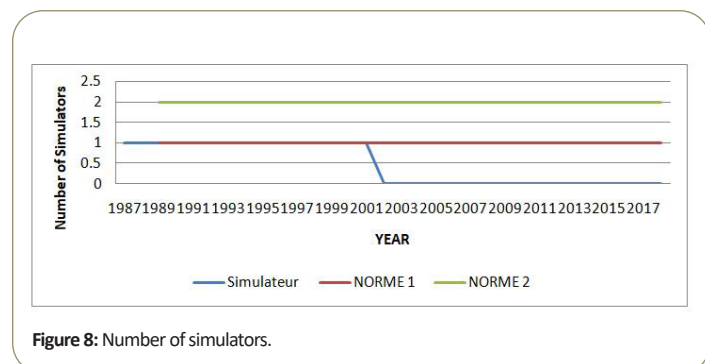
The simulator: From **Figure 8**, it can be seen that from 1989 to 2001, the center has a compliance rate equivalent to norm1 pertaining to simulation equipment (VERASIM). This rate becomes zero (and equivalent to that observed at the GHY [3]) from 2002 following an unrepaired failure of the simulator. This failure significantly affected the treatment circuit of patients and their radiation protection, representing a huge disruption. Consequently, the determination of the regions of the body to be treated and the organs to be protected was no longer optimally done. This disruption due to the absence of the simulator will push radiotherapists to perform manual simulations directly on the patient during the first irradiation session, using their knowledge of human anatomy and medicine. Thus, in order to make the treatment circuit proposed to patients more efficient, the GHD should equip itself with RT simulation equipment for which it will have to provide quality maintenance.

Figure 8: Number of simulators.

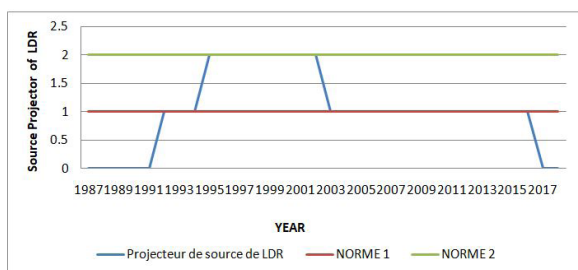
Brachytherapy unit: From **Figure 10**, from 1989 to 1991, the GHD RT service had no brachytherapy equipment, including the LDR source projector. Between 1992 and 1994, it operated under a 100% compliance rate of norm 1 by acquiring its first LDR source projector (CERVIFIX) and then evolves at a 100% compliance rate of norm 2 between 1995 and 2002 with a second LDR source projector (AMRA, cesium 137). The compliance rate of the number of LDR source headlamps dropped to 100% of norm 1 in 2003 and remained there until 2016 before becoming zero again in 2017. Thus between 1995 and 2002 brachytherapy treatments were at their peak with the simultaneous presence in the service of two LDR source projectors for a fairly bearable number of patients as recommended by the IAEA. From 1989 to 1991, the lack of a brachytherapy machine was probably due to the embryonic state of the department, which had first to analyze the demand, a response to demand confirmed by the equipment endowments LDR between 1992 and 1995. The same non-existence of brachytherapy machines was found in several African countries such as Congo, Uganda and Liberia by F.A Durosini-Etti (1991), showing their delay in terms of brachytherapy at African countries such as Egypt, Senegal and Kenya were already offering brachytherapy care. This situation worsened considerably after 2016 due to the same causes leading to the lack of LDR brachytherapy equipment (which in many ways was not well suited to the situation) within the HGD's RT service. These perturbations are probably due to uncorrected breakdowns of brachytherapy equipment and/or non-renewal of the equipment concerned. Thus in order to respond appropriately to the growing demand for care for cancer cases such as cervical cancer, the HGD should have a brachytherapy service that is more suitable and why not more modern.

Figure 10: Number of LDR source floodlights.

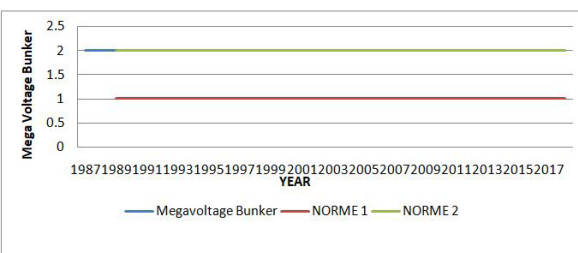
The bunker has megavoltage: Since the opening of the center, it has always operated with a compliance rate of 100% to norm 2 for megavoltage bunker (Figure 11). This rate is largely in line with the IAEA recommendation and clearly addresses the number of patients treated at the GHD in recent years.

Figure 11: Megavolt bunker number.

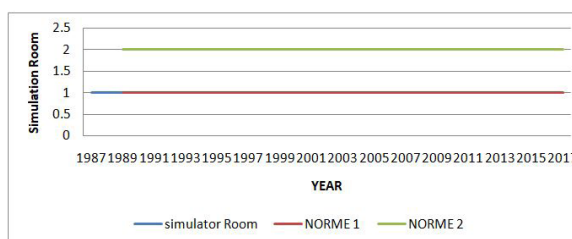
The simulator room: The center has always had a 100% compliance rate with norm 1 for the simulator room (Figure 12).

Figure 12: Number of simulator rooms.

This rate is in line with the IAEA recommendation. However, the failure of the VERASIM simulator in 2002 significantly affected the operation of the GHD simulator room. This is why, due to the lack of equipment in this room, it has been converted by the staff into classroom and meeting room. It is clear that in order to provide the best quality care, the GHD should equip this room with the device for which it was reserved.

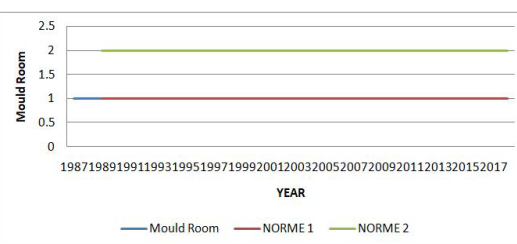
The mold room: The GHD RT service has always had a 100% compliance rate with norm 1 for the mold room (Figure 13). This rate is in line with the IAEA recommendation. However, it should be noted that as soon as the center was opened the CEROBEN Polystyrene and Casting Shop installed in this room was never used due to the lack of CEROBEN alloy. This absence hindered treatment sessions: patients have never owned a personalized cache, which no doubt increases the risk of risky organ irradiation or nearby healthy tissue to tumor masses; making the treatments less optimal. To mitigate this disruption in service, the HGD should either supply this alloy or procure a new, more modern personalized cache maker.

Figure 13: Number of mold rooms.

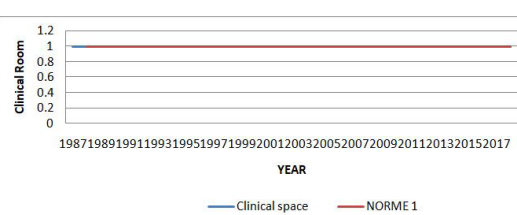
The clinical space: Since 1989, the center has a 100% compliance rate with norm 1 for clinical space (Figure 14). This clinical space is in accordance with the IAEA recommendation. It has a fairly large clinical area including: examination rooms, doctors' offices, a physicist's office, waiting rooms (invalid and invalid patients) having been enlarged in 2017, undressing rooms and a secretariat.

Figure 14: Number of clinical space.
